**EVALUATION OF
MINE-WATER DISCHARGE IMPACTS IN
ECCLES CREEK AND MUD CREEK**

**CANYON FUEL COMPANY
Skyline Mine
Scofield, Utah**

December 2002

EARTHFAX ENGINEERING, INC.
Engineers/Scientists
Midvale, Utah

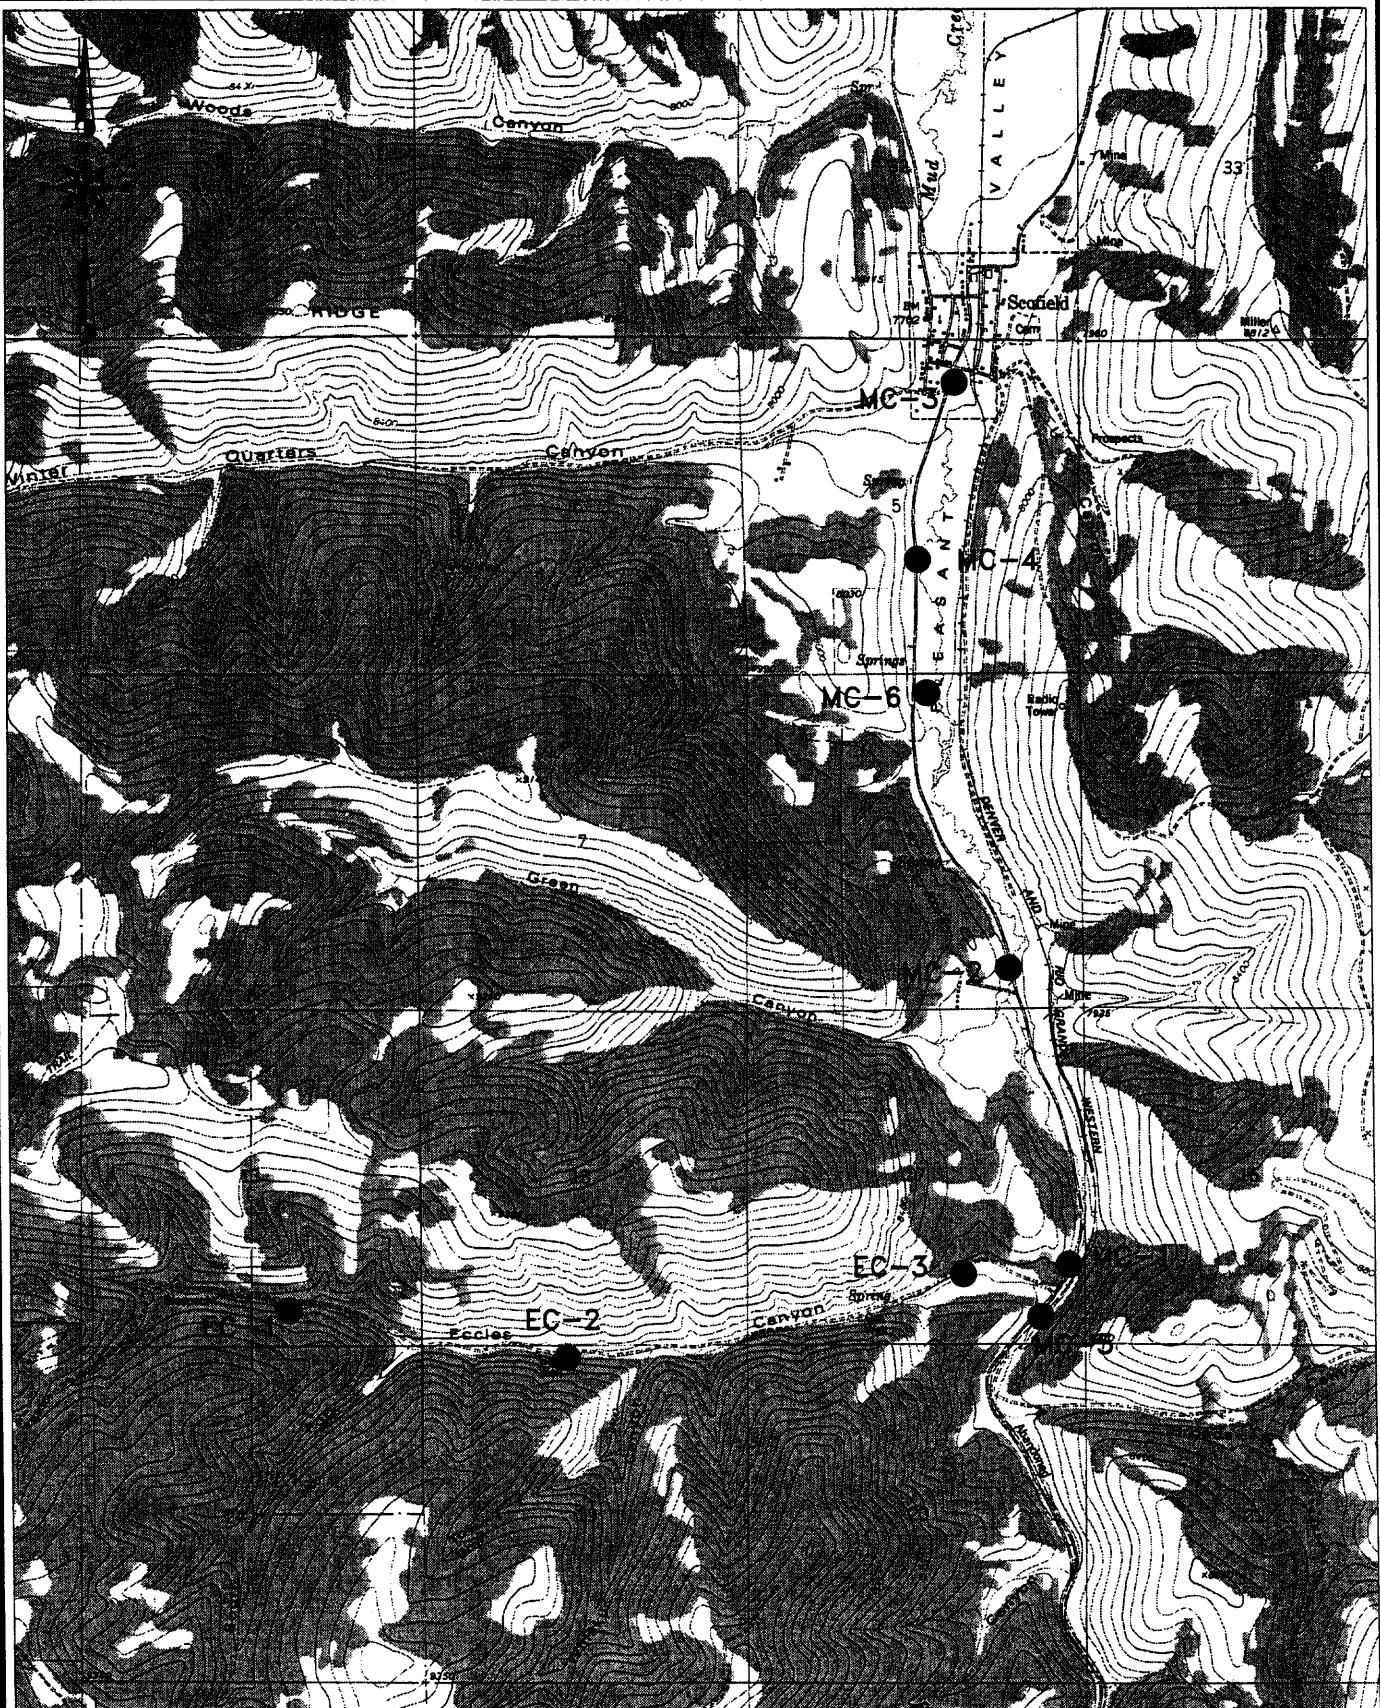
BASE MAP: USGS 7-1/2 MIN. QUADRANGLE
SCOFIELD, UTAH (1979)

Reference sites were established on Eccles and Mud Creeks at the locations shown on Figure 2-1. Sites EC-1, 2, and 3 as well as MC-1, 2, and 3 correspond to cross section locations used in previous investigations (EarthFax Engineering, 2002). Sites MC-4, MC-5, and MC-6 were established to evaluate conditions on Mud Creek within a section of agricultural pasture (MC-4 and MC-6) and upstream from the Eccles Creek confluence (MC-5). A portion of the Mud Creek flows are diverted upstream of MC-4 for flood irrigation purposes in an extensive area near MC-4. As a result, the water table is artificially high at MC-4 and not representative of natural subirrigation that might occur in Pleasant Valley. MC-6 was therefore established upstream from the diversion to serve as a monitoring point in an area not affected by flood irrigation.

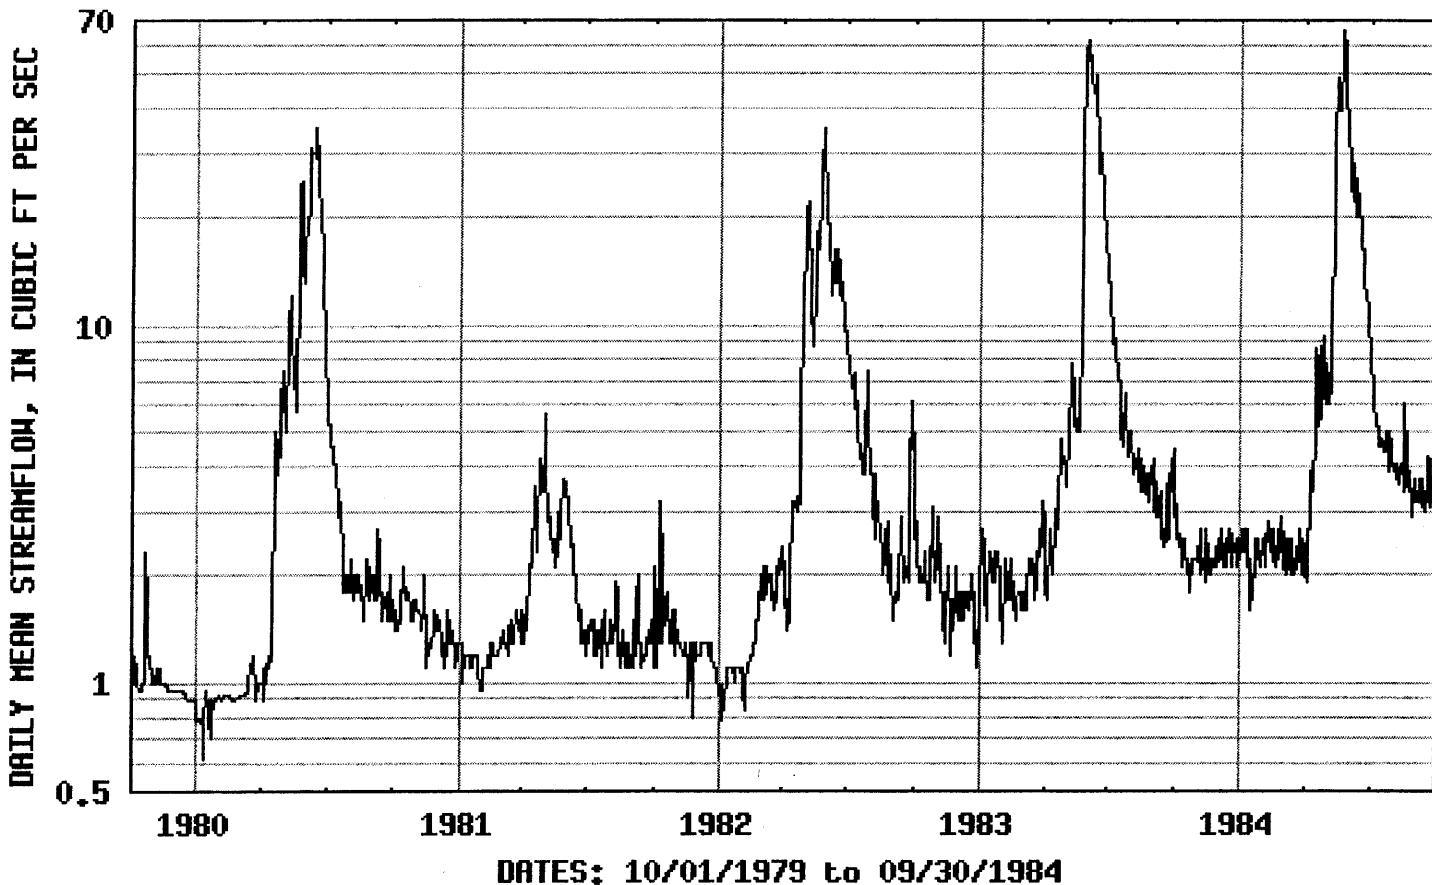
Figure 3-1. USGS Eccles Creek Streamflow Record

USGS 09810600 ECCLES CANYON NEAR SCOFIELD, UTAH

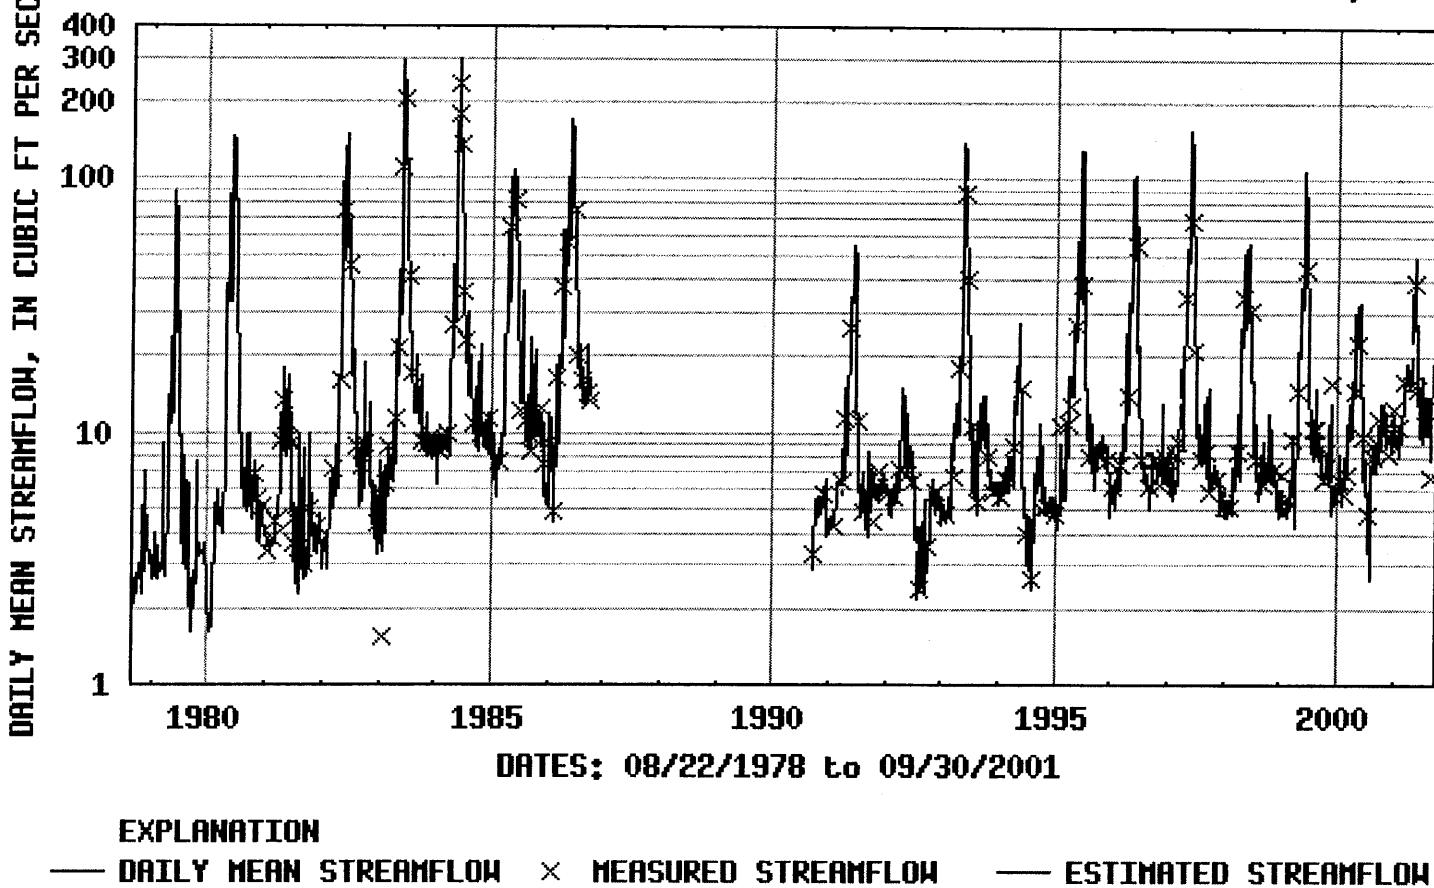
Figure 3-2. USGS Mud Creek Streamflow Record

USGS 09810700 MUD CREEK BL WINTER QUARTERS CANYON AT SCOFIELD, UT

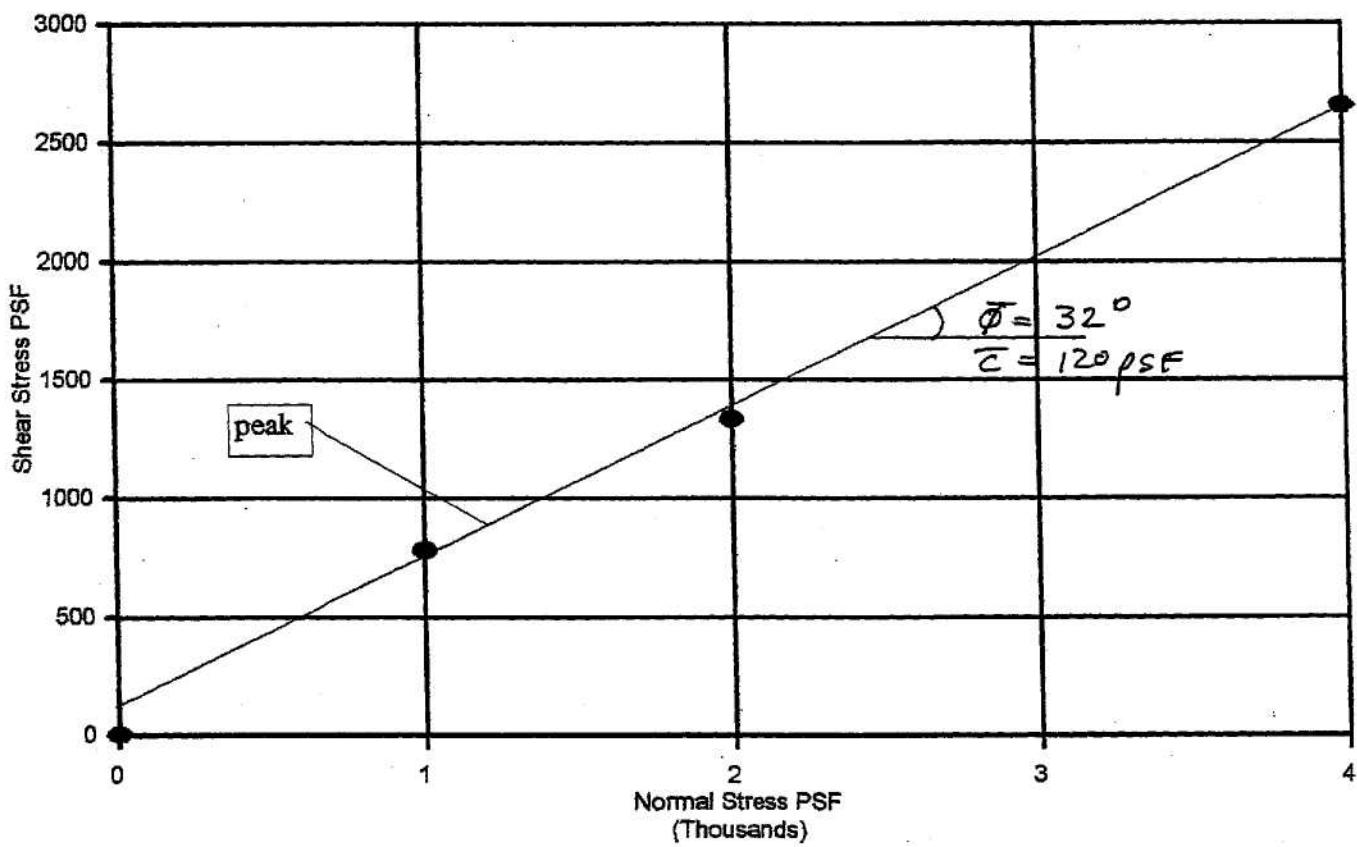
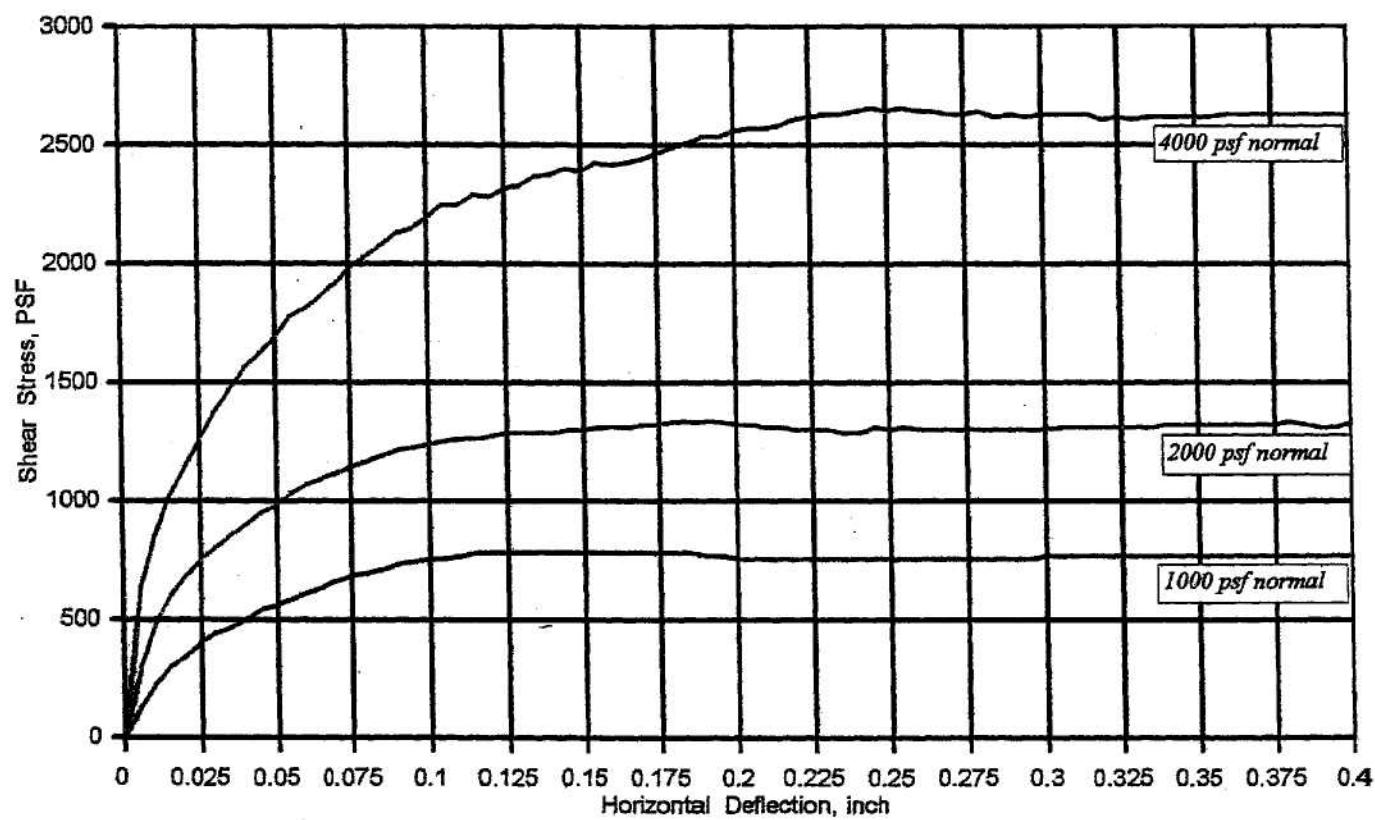
DIRECT SHEAR - Consolidated Drained EC-2 S

Sample EC-2 S

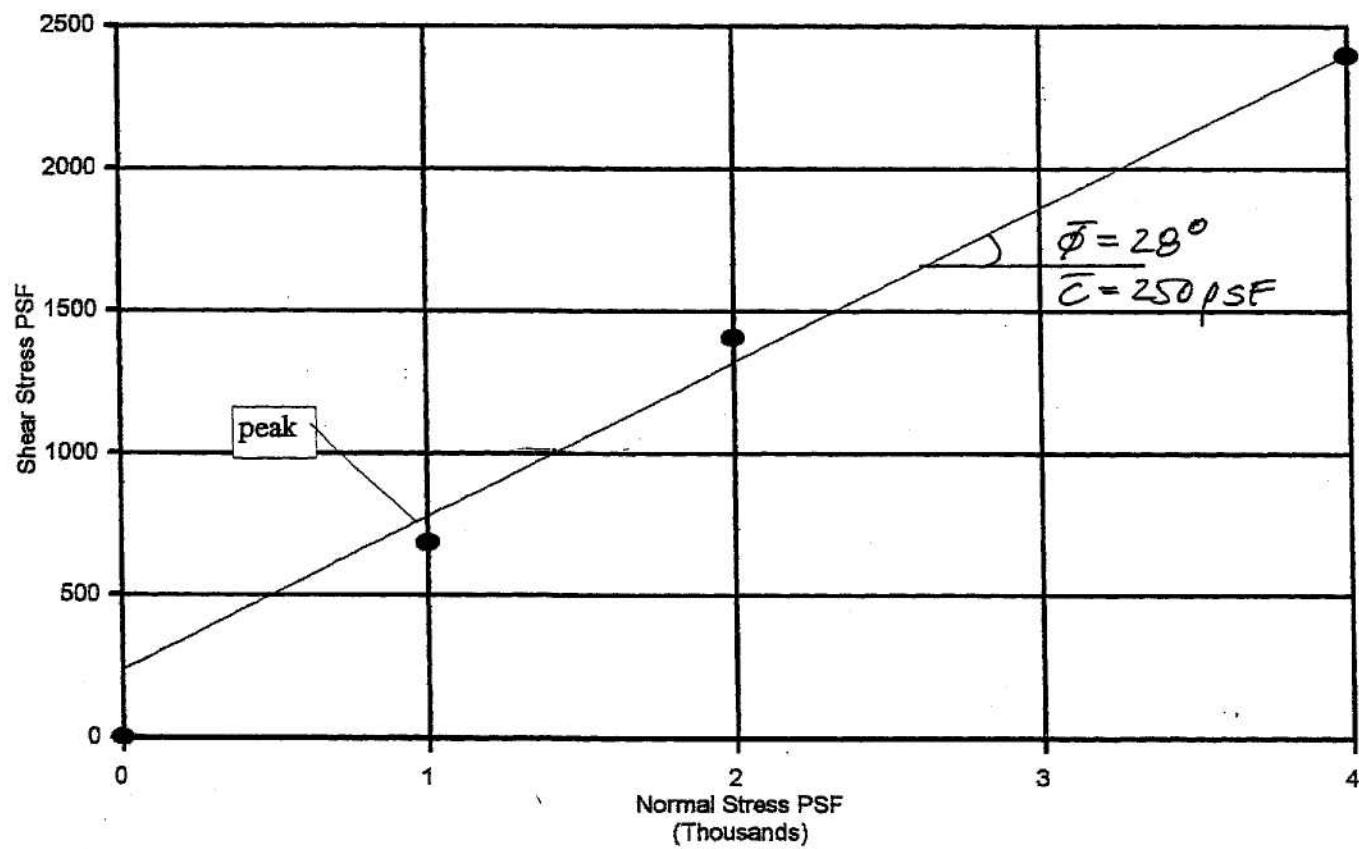
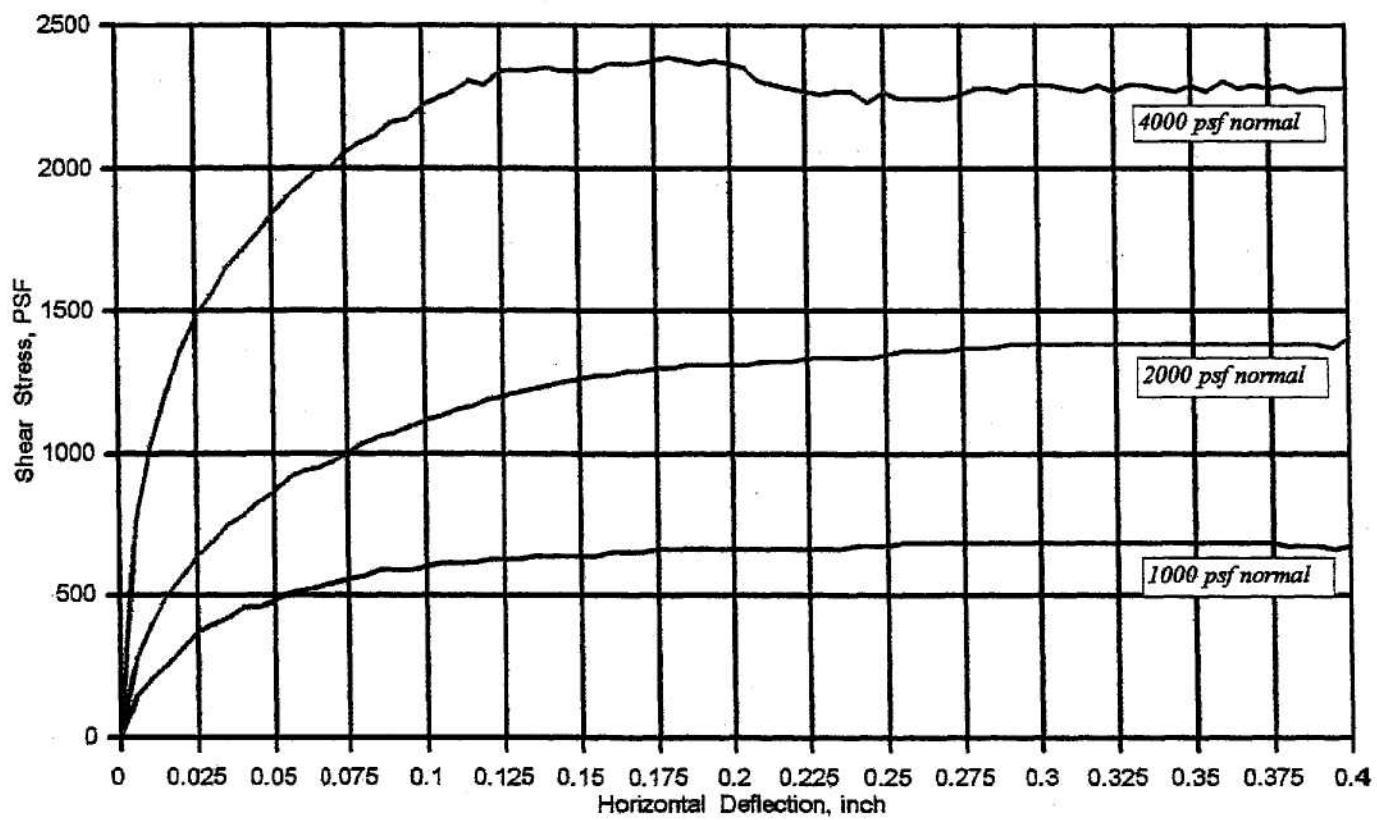
DIRECT SHEAR - Consolidated Drained EC-3 S

Sample EC-3 S

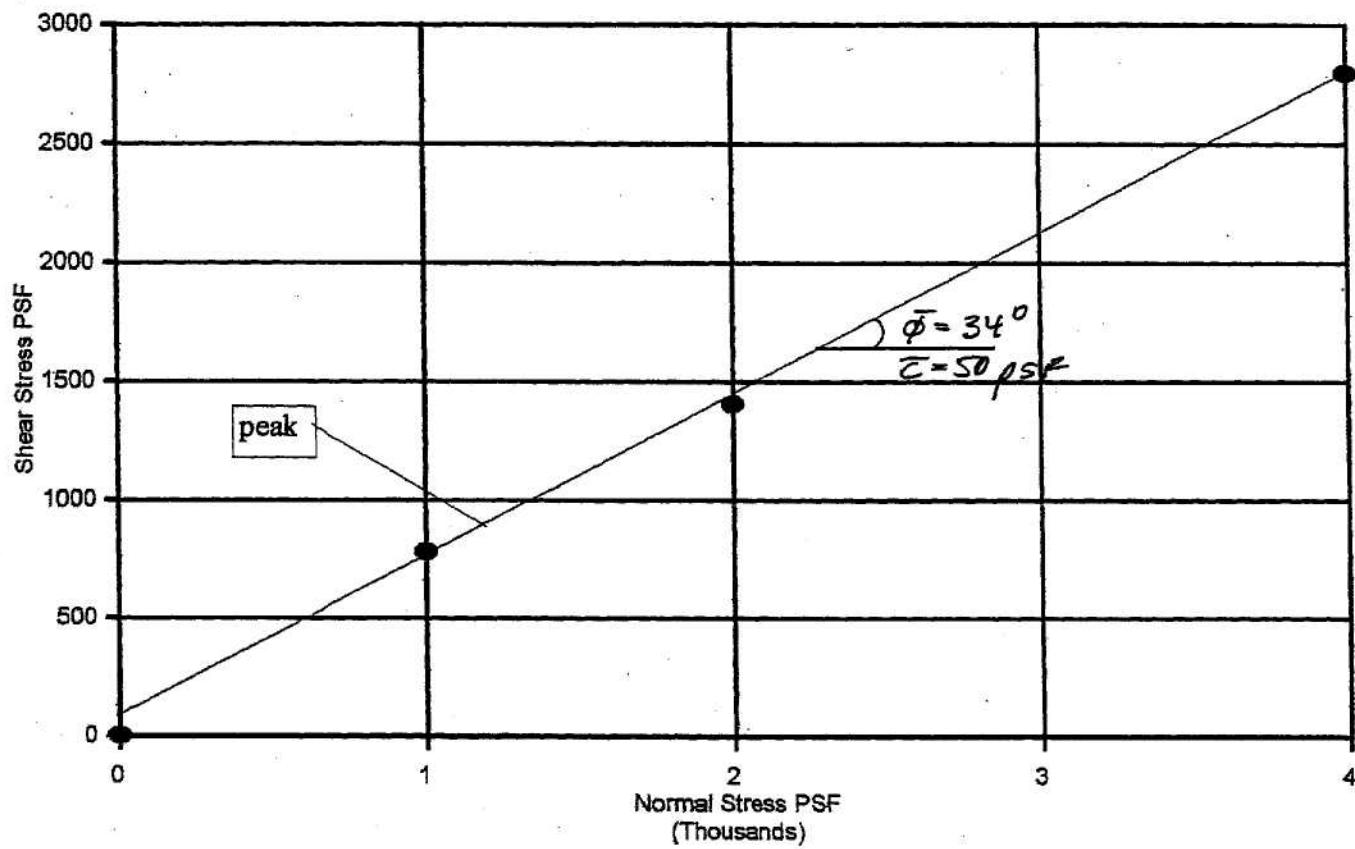
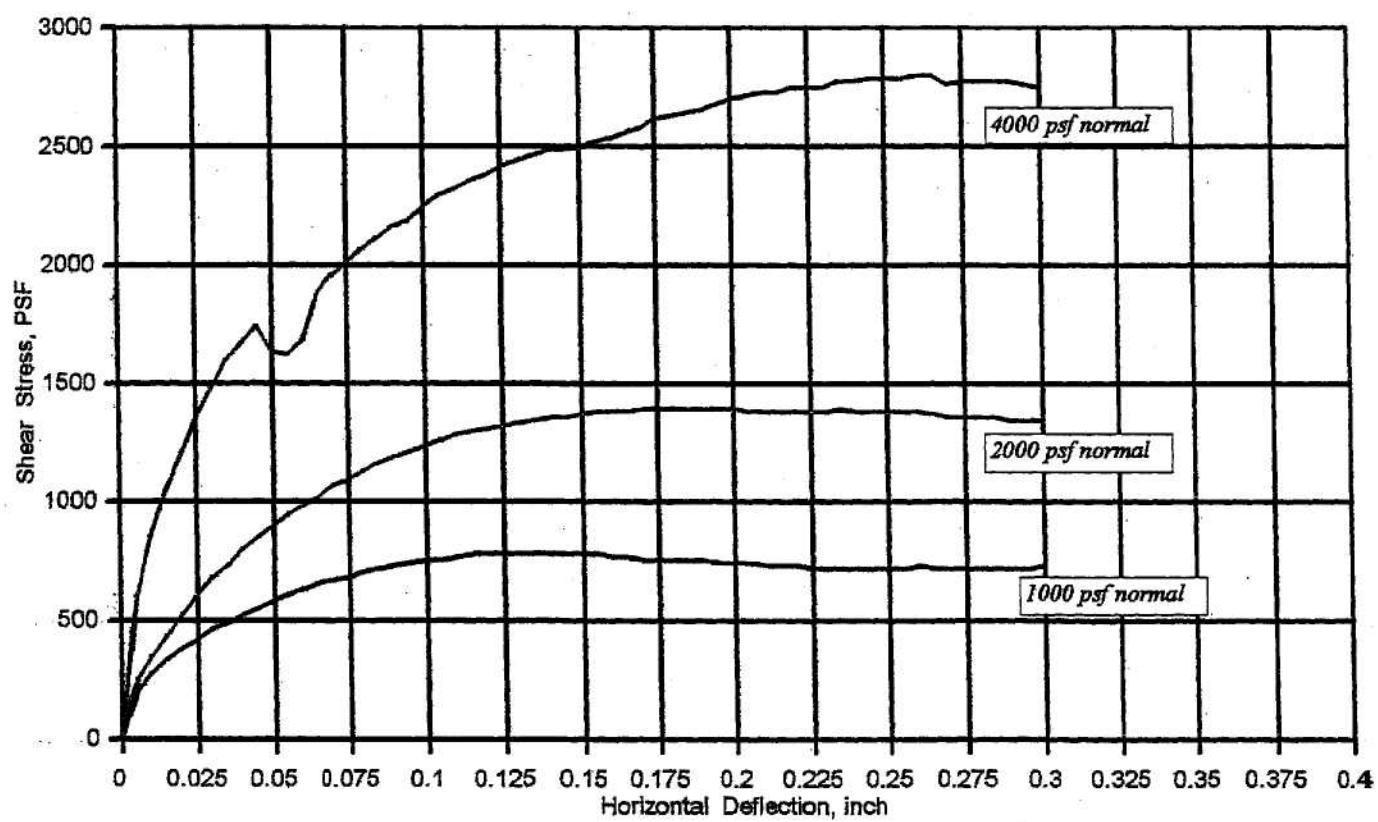
DIRECT SHEAR - Consolidated Drained MC-1 S

Sample MC-1 S

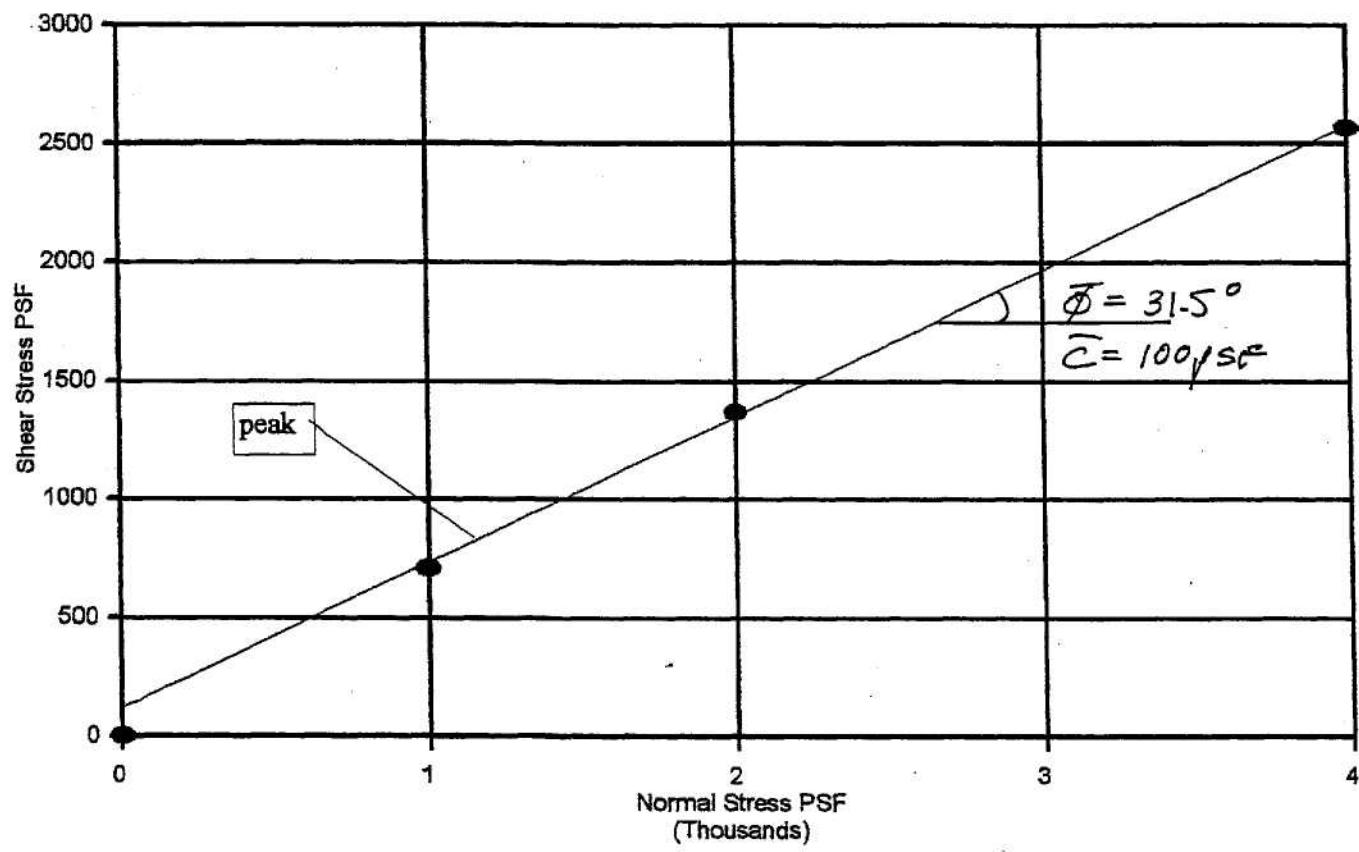
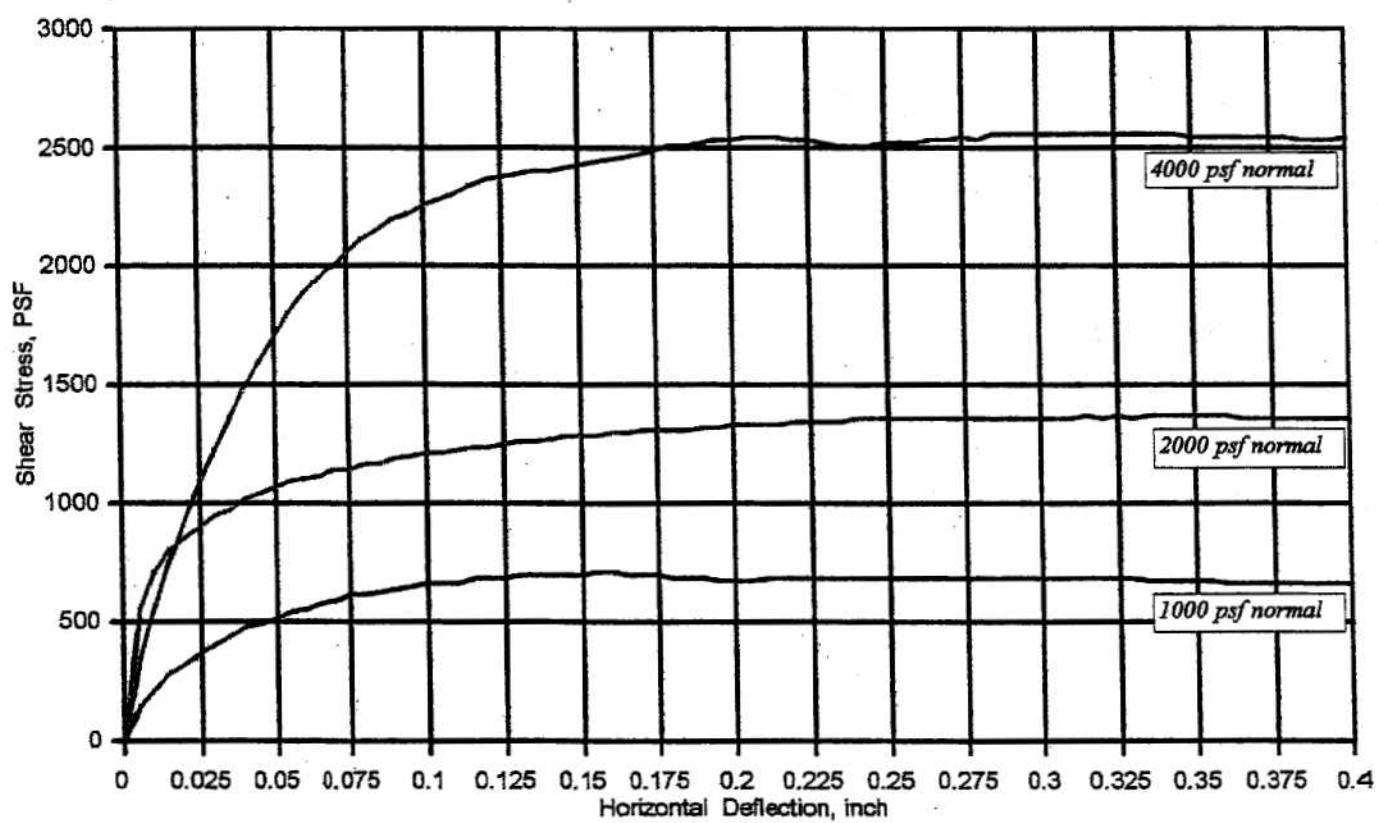
DIRECT SHEAR - Consolidated Drained MC-2 S

Sample MC-2 S

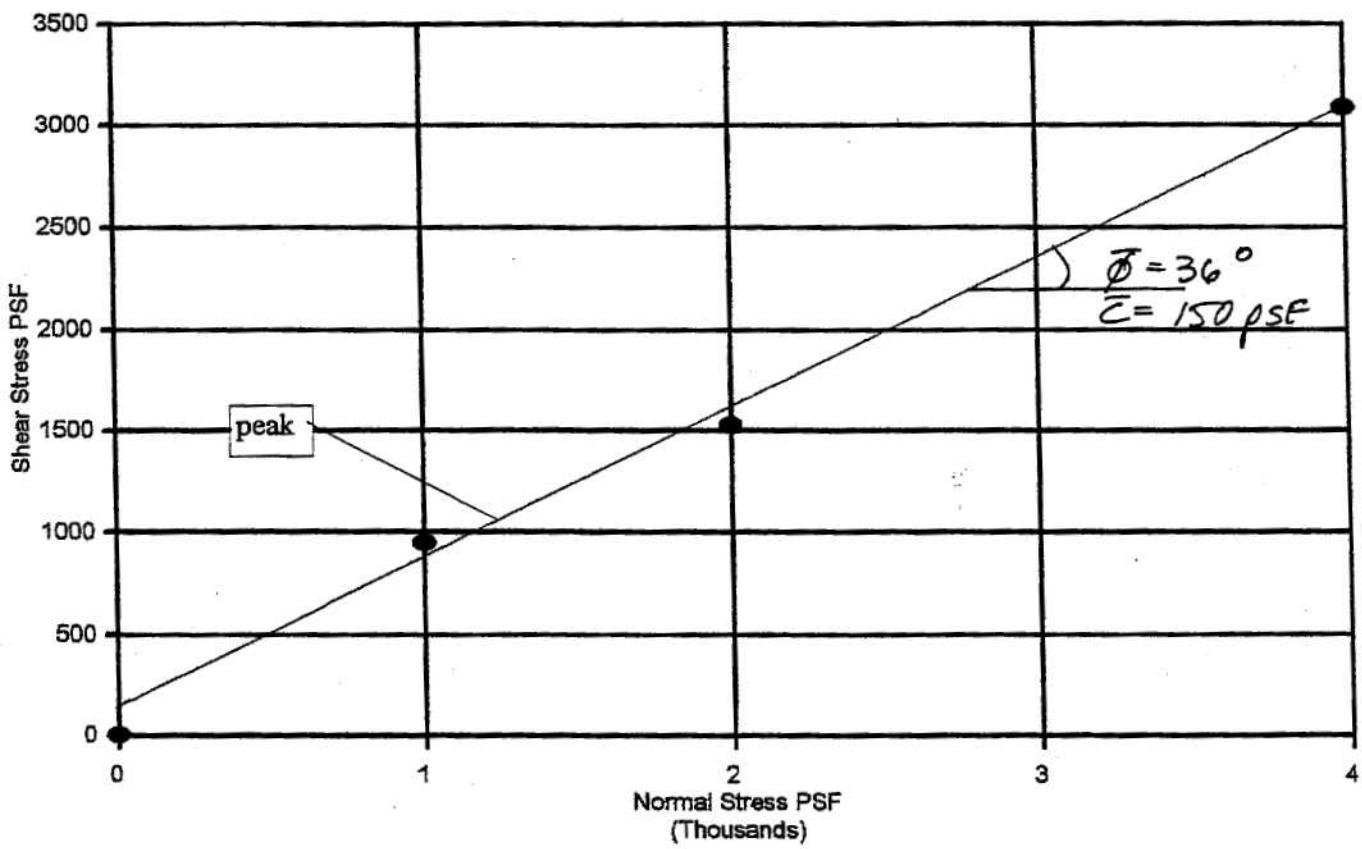
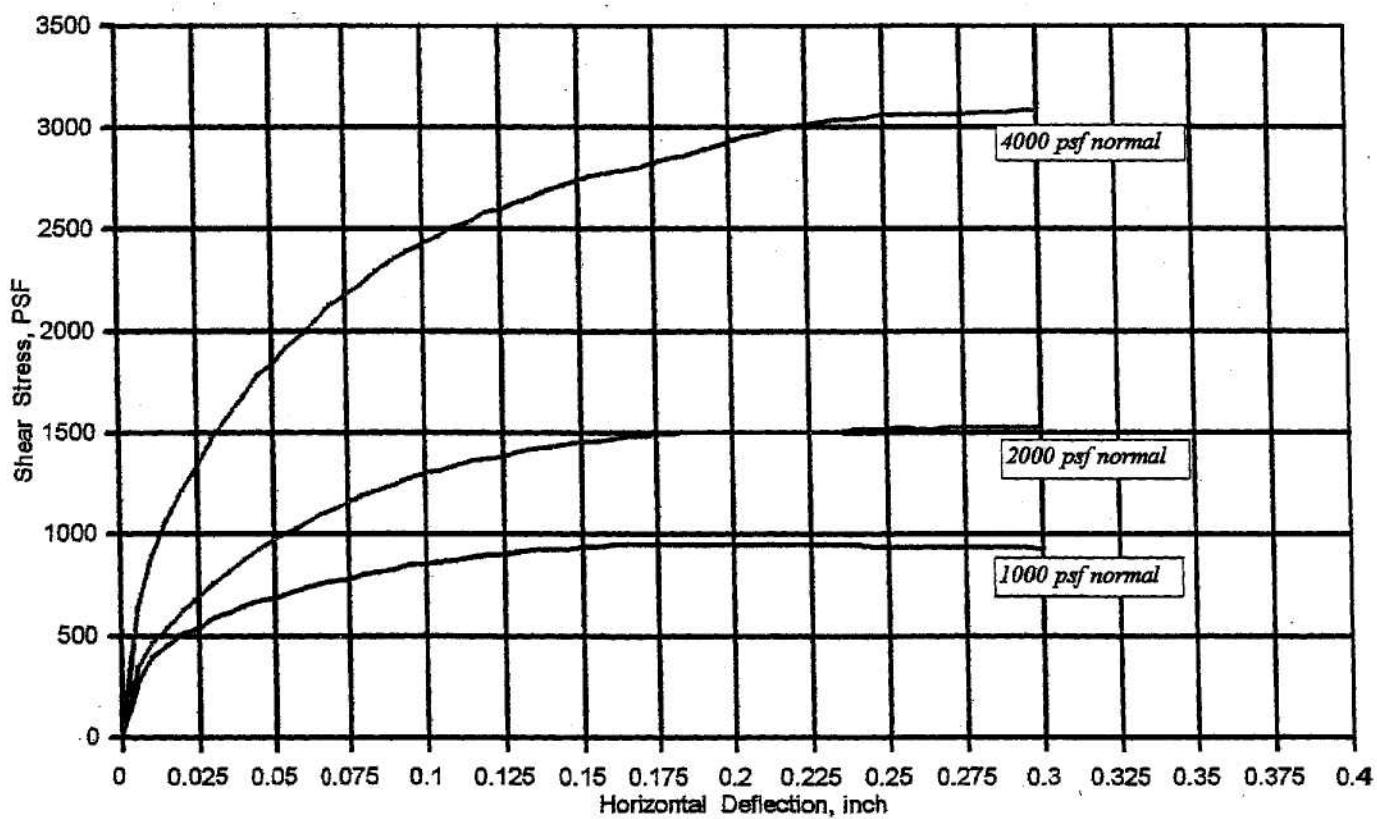
DIRECT SHEAR - Consolidated Drained MC-3 S

Sample MC-3 S

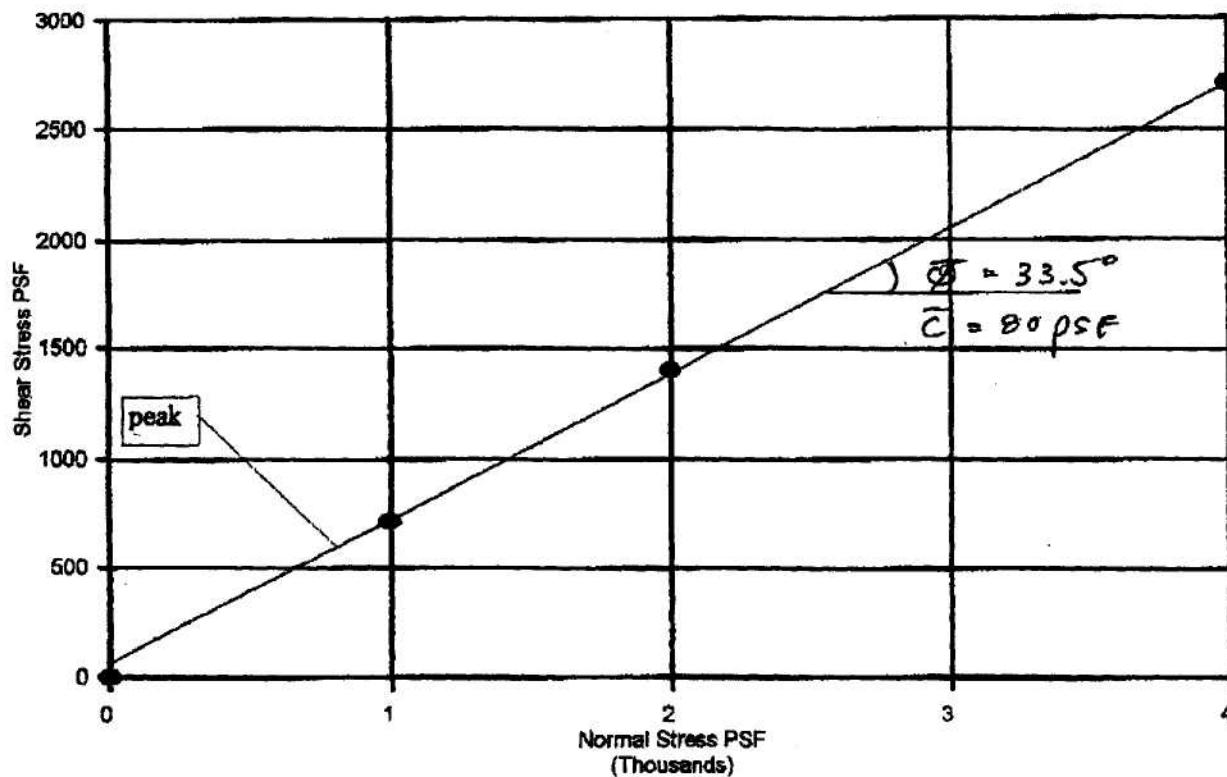
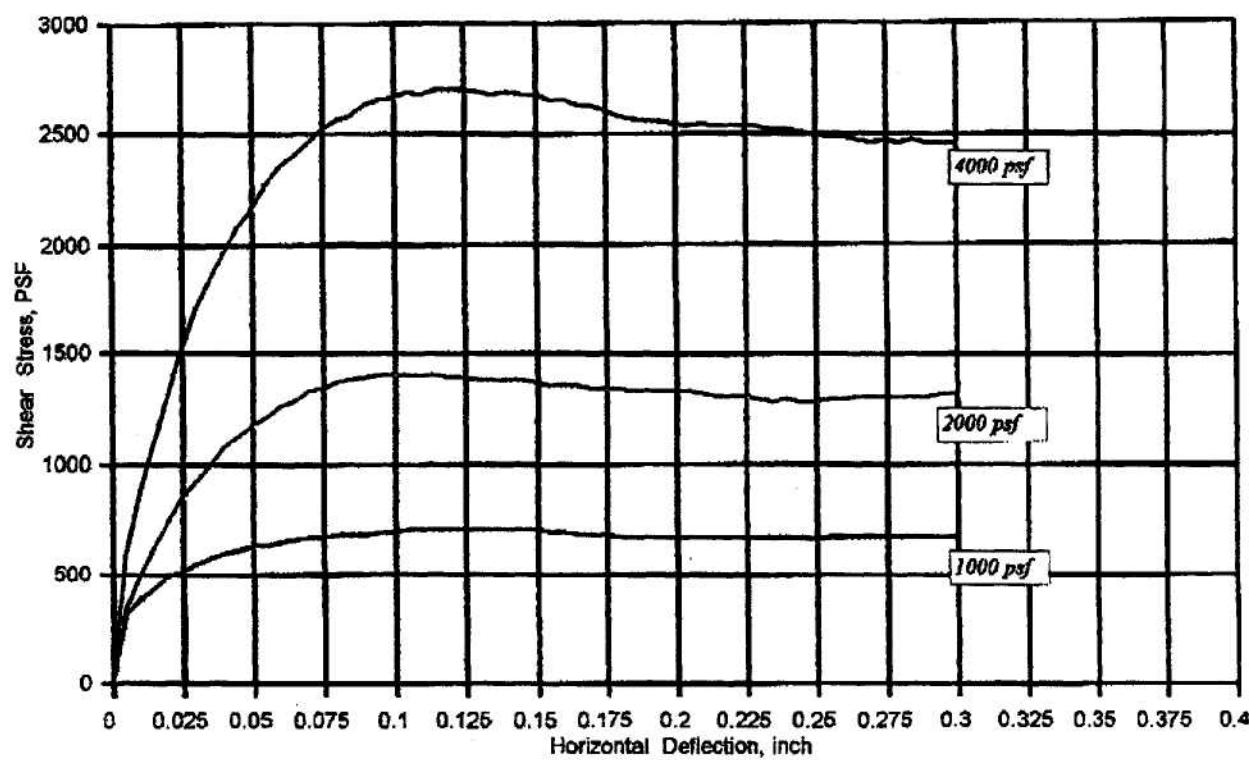
CMT, Boring MC-5, collected 8/14/02

CMT, Boring MC-5

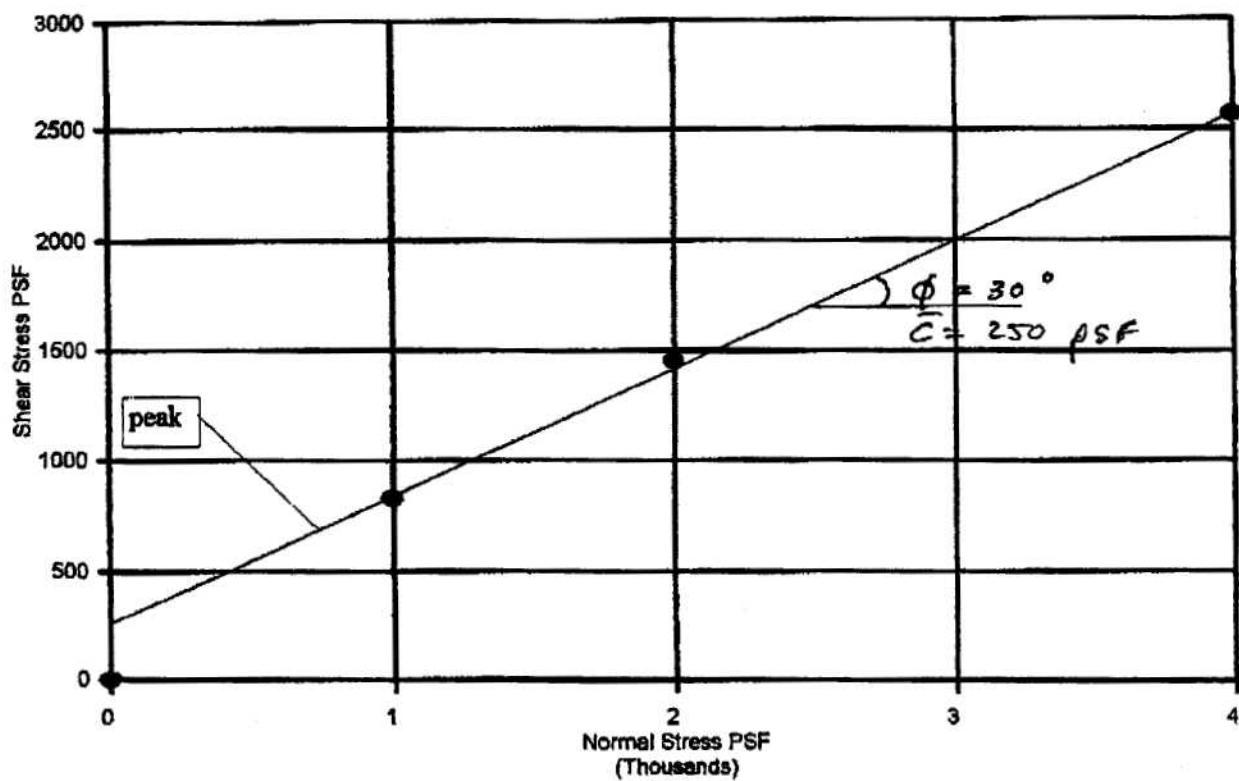
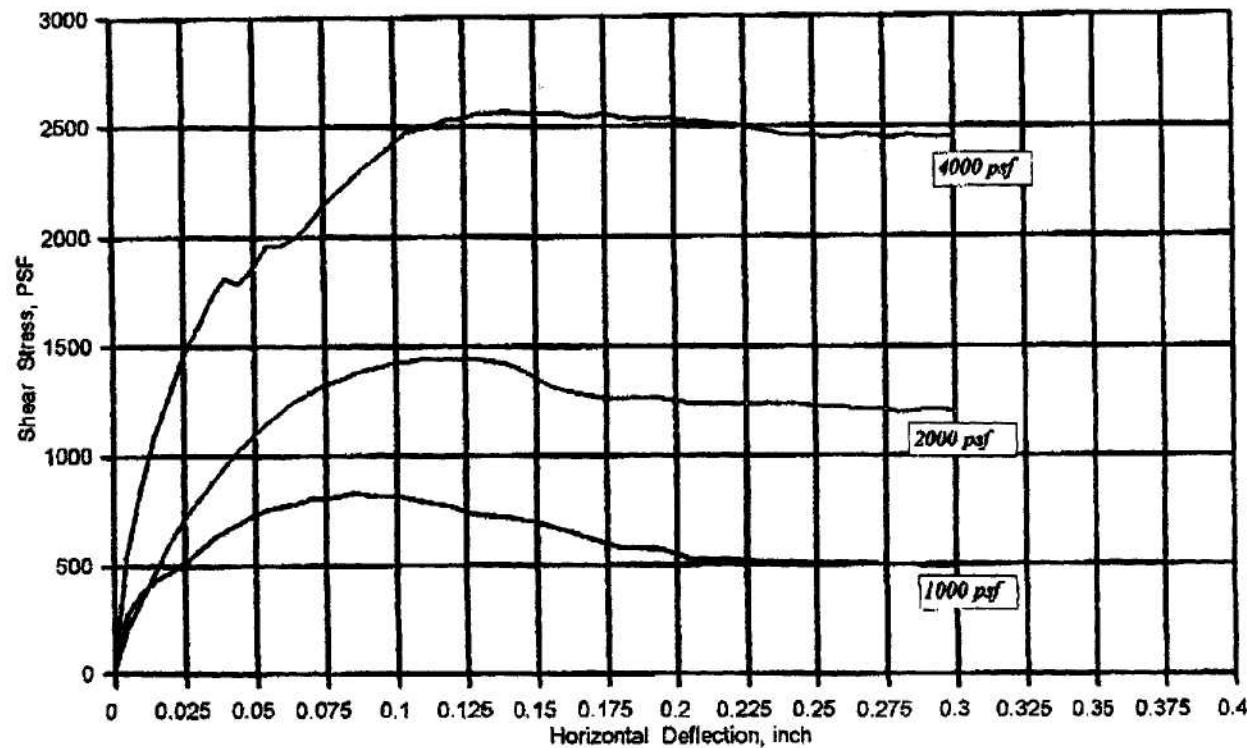
CMT, Boring MC-4S, collected 8/14/02

Direct Shear
CMT, Boring MC-4S

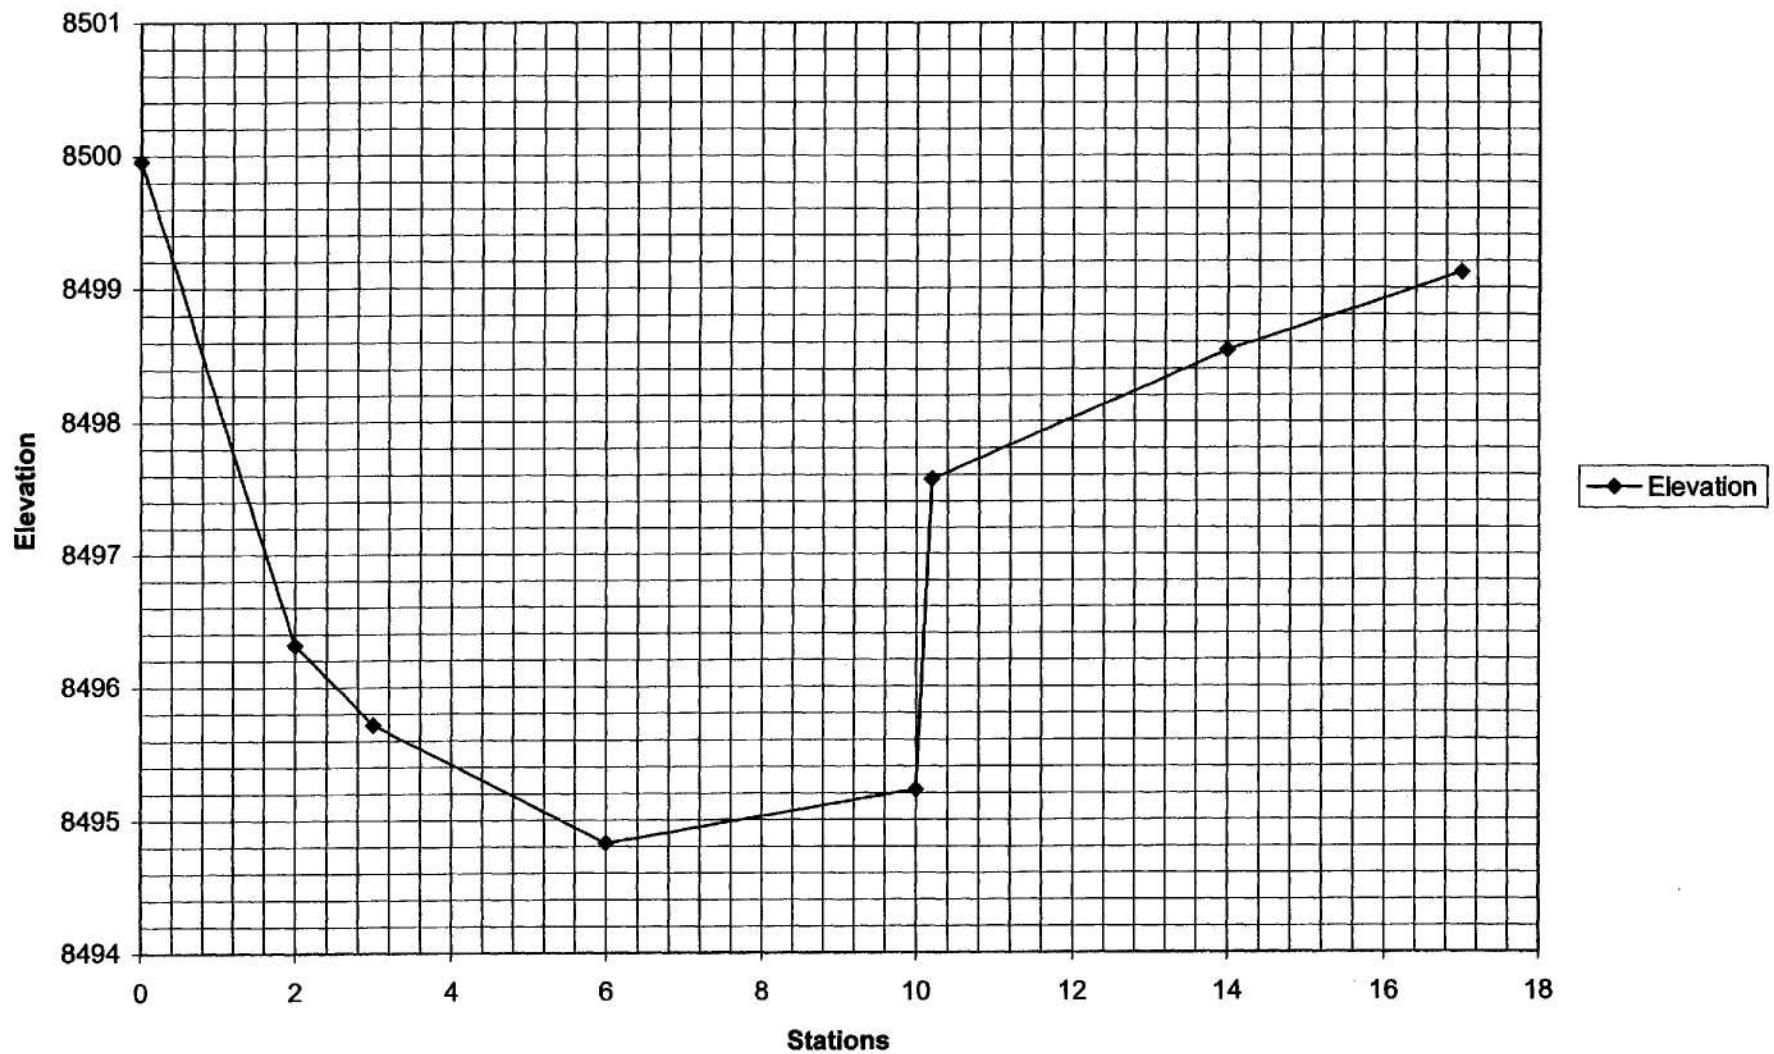
Cross-Section EC-1

Cross Section: EC-1 Elev: 8499.127
